Tudor Walk

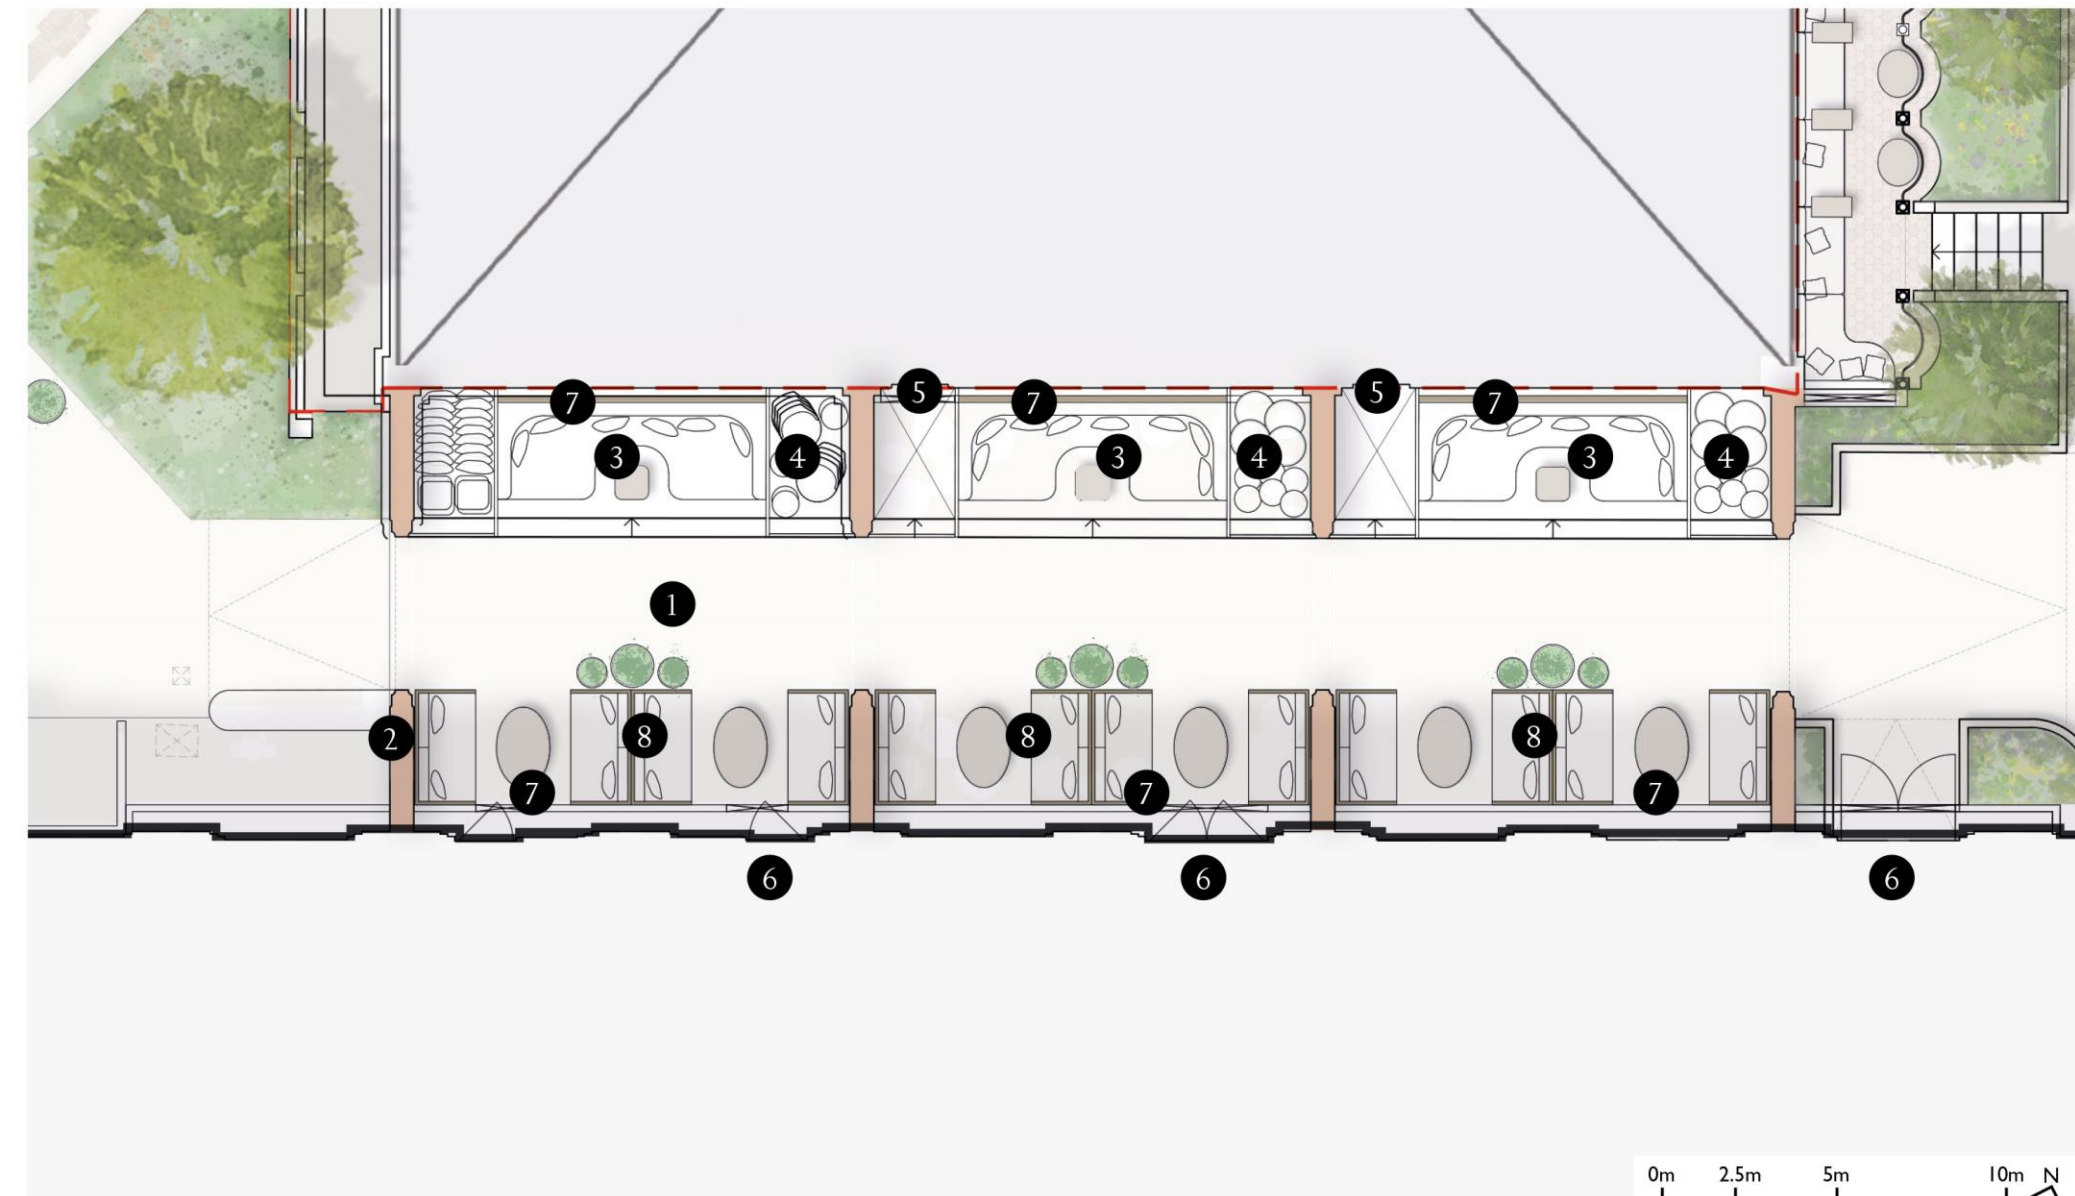
Tudor Walk Character Area (Scale 1:125)

The Tudor Walk is a series of Tudor arches, similar to those on Hancock's New York garden, located between the English and Spanish Gardens. They have suffered from considerable erosion from the elements over the years, and are littered by plant and infrastructure.

The arches are proposed to be conserved and repaired as far as possible, and an elevated glass roof is proposed in order to protect them from future damage.

A timber trellis previously screened the northern elevation of the Sun Pavilion and plant rooms, which no longer survives. An ornate trellis is therefore proposed to be reinstated to screen the plant rooms, whilst still permitting access.

All electrical and fire escape infrastructure that currently detracts from the Tudor Walk will be removed to make way for seating either side of the arches to encourage the use and enjoyment of this space.

The northern seating is proposed to be designed to float over the top of the existing planter, with storage space for the furniture, and maintenance access routes to be maintained to the landlords demise.
